Manhole Inspection Summary

Manhole # S15GG1005MH

Location Address: **4111 ROLAND VIEW AVE**

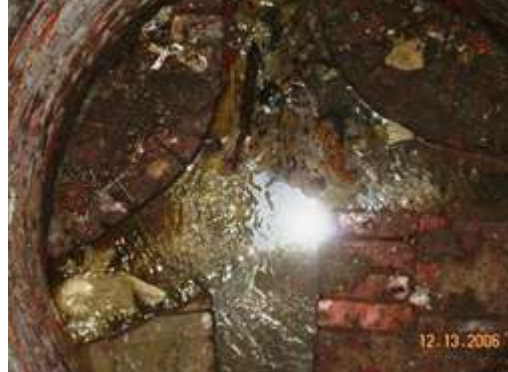
Top View

Evidence of surcharge - Bench debris.
Channel debris. Bench deterioration.

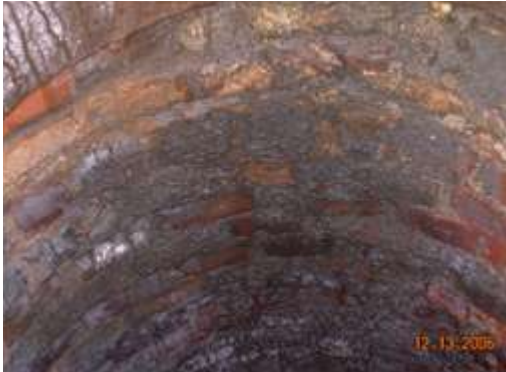
Defect

Frame leaks. Adjustment deterioration
and infiltration.

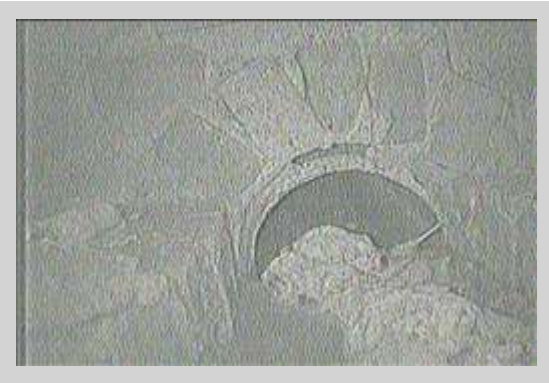
8 in. Circular Gravity Sewer Pipe Out @ 12 O'Clock

Deposits: ☐ None ☐ Mud ☐ Sludge ☒ **Debris** ☐ Grease

Silt Depth: **3** (in.) Deposits Extent: **Medium**

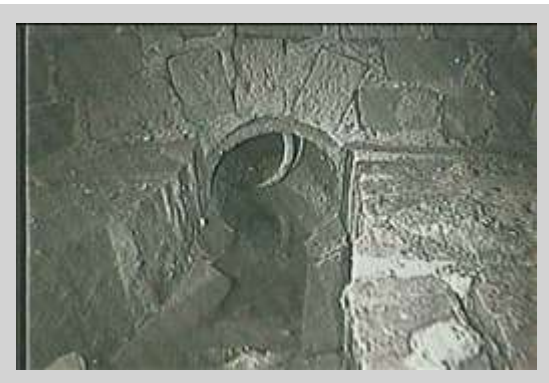
6 in. Circular Gravity Sewer Pipe In @ 3 O'Clock

Offset joint inside of the pipe. Channel and Barrel deterioration.

Infiltration: **Evidence** Pipe Seal Cond: **Unknown**

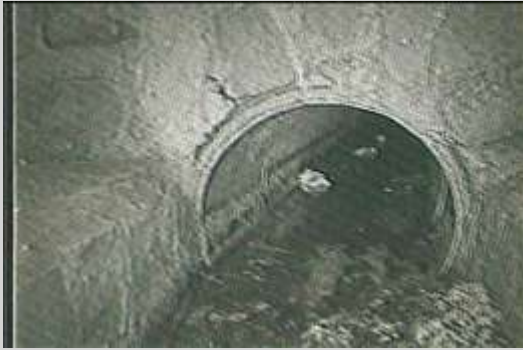
Pipe In @ 6 O'Clock

Deposits: ☐ None ☐ Mud ☐ Sludge ☒ **Debris** ☒ **Grease**

Infiltration: **Evidence** Pipe Seal Cond: **Cracked**

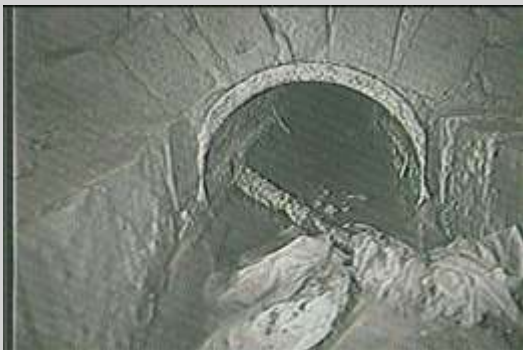
Pipe In @ 8 O'Clock

Deposits: ☐ None ☐ Mud ☐ Sludge ☒ **Debris** ☒ **Grease**

Infiltration: **Evidence** Pipe Seal Cond: **Cracked**
